This is a restudy and new solution of Case Study House Number 1, as proposed by J. R. Davidson, and is the ninth in the continuing series of Case Study Houses being presented by the magazine, Arts & Architecture. Construction is now in progress on a 100' x 125', moderately level lot in a centrally located neighborhood in North Hollywood.

case study house

J. R. DAVIDSON
DESIGNER

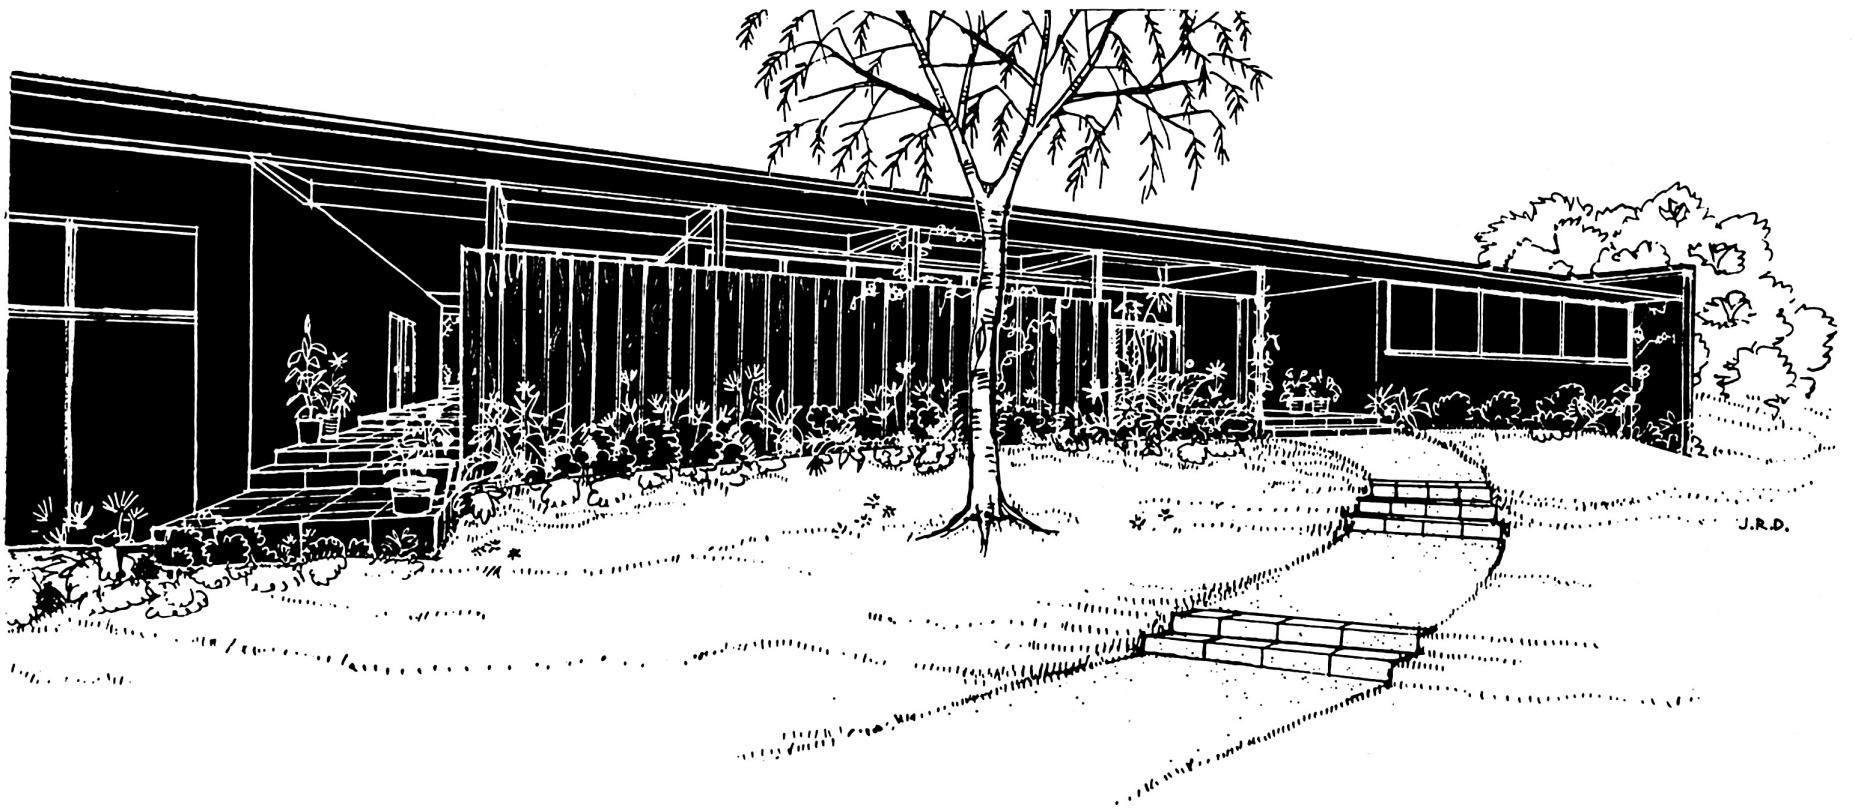
The house is planned for a hypothetical family consisting of a couple in early middle age, both active in careers which keep them away from home frequently. It has been developed with special consideration for an abundance of light and air, easy housekeeping and minimum maintenance, with emphasis on indoor-outdoor living. The rear property line is formed by a row of high eucalyptus trees, which, combined with the 12'-above-street-level elevation, give the property a natural privacy. Other existing trees will become a part of the over-all landscape development. By orienting the house diagonally, a better exposure to the sun is gained, as well as an easier driveway. The garage floor is 4' lower than that of the house, and is connected to it by steps combined with a low incline ramp.

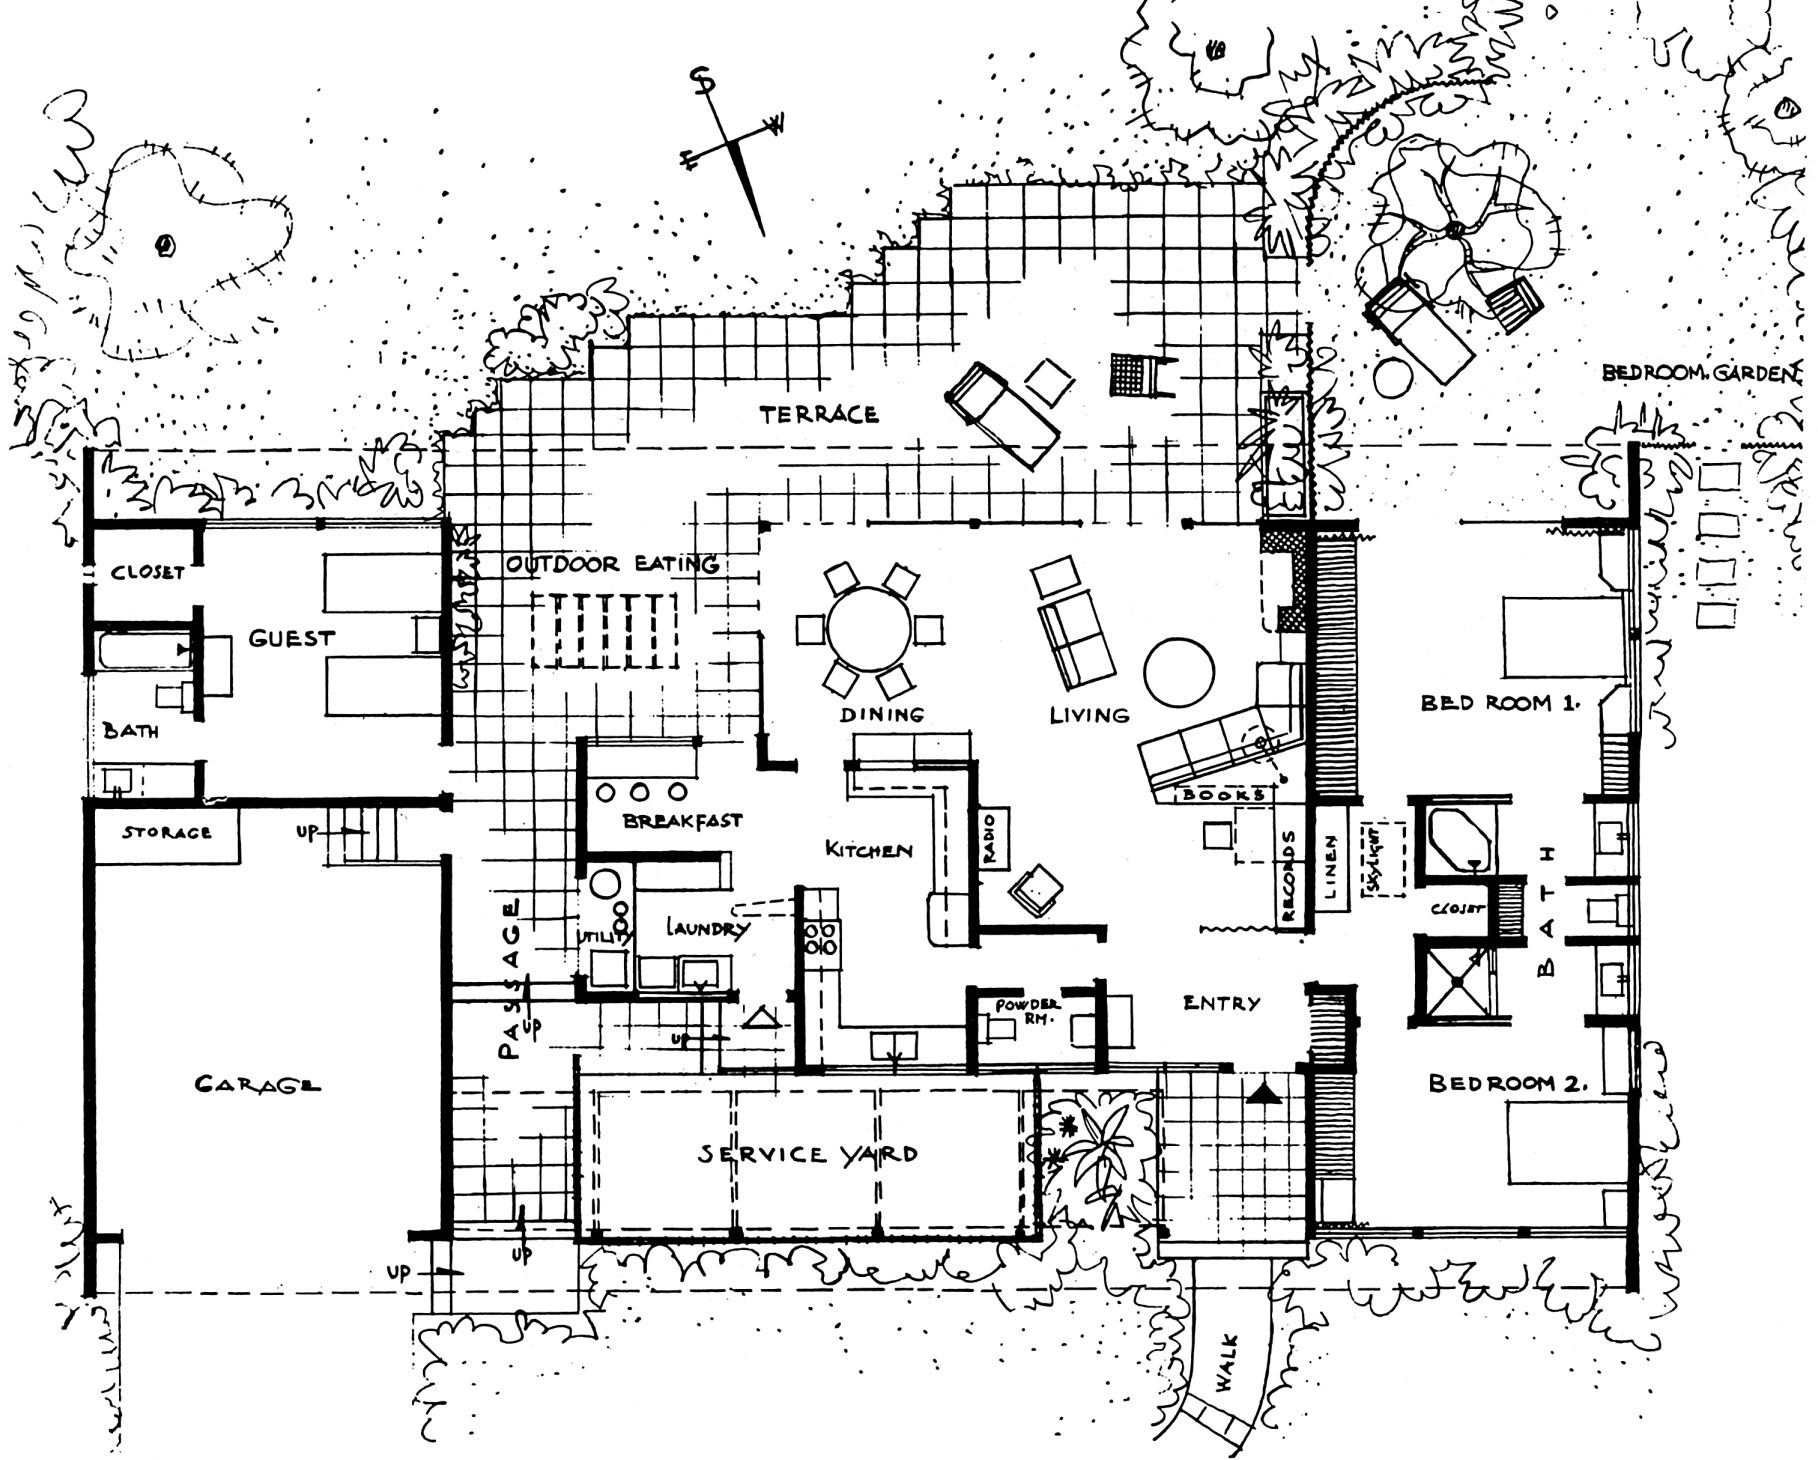
Ample provision for ease in entertaining large gatherings of friends, both indoors and outdoors, is an important consideration. A garden adjacent to the master bedroom and separated from the main garden by a high circular fence affords a quiet area for sun bathing and rest. Two bedrooms are separate but connected by a combination bath. A 7' wide passage divides the guest quarters from the house, both units being under one roof. Maximum garden area is assured by placing the service yard on the street side and making it an architect-

The structure is standard wood frame on a reinforced foundation with water-proofed reinforced concrete slab floor. Exterior is of the new aluminum siding. Interior finish is painted plaster except the north wall in the dining room, which is paneled in hardwood ply. Floors, carpeted throughout the living areas and bedrooms; asphalt tile in bathrooms, kitchen, laundry, breakfast alcove. All north walls and ceiling are well insulated. Roofing, built-up type. All soffits of the overhang, as well as the ceiling in the passage and outdoor eating porch, are of waterproof plywood. All working surfaces in kitchen, breakfast counter, lavatory tops, including splashbacks, are covered with formica.
